## THE WEST GATE, WINCHESTER, 1940.

By B. H. ST. J. O'NEIL, M.A., F.S.A.

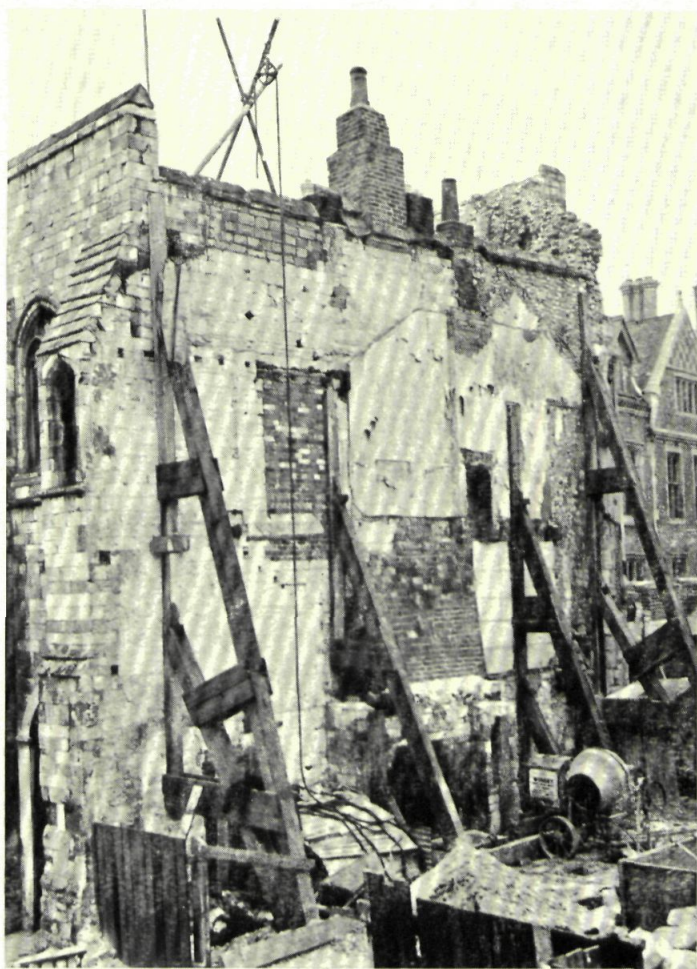
PLATE I.

THE northern face of the West Gate at Winchester was an unlovely sight after the removal of the modern buildings, which had been built up against it (Fig. 1). Not only was much of it covered with wallpaper, but there was considerable evidence of modern re-facing or patching of the ancient face and of modern openings cut through the wall and subsequently blocked. Moreover, there were three brick chimneys projecting from the parapet line, only one of which was then in use for the fireplace within the gate tower itself.

The removal of modern work necessitated especial care because of the uncertainty as to the stability of the whole structure, which stands upon an inclined chalk dump of very early formation, and also to the fact that the cutting of two modern chimneys had certainly caused many fractures in the north wall. As a precaution, therefore, the whole wall was strongly shored and the space left by cellars of the "Plume of Feathers" was filled with concrete and dry rubble. Thereafter, as soon as possible, two horizontal reinforced concrete beams, 12in. by 9in. in section, were inserted 9in. behind the face across the north wall fractures. They run the full length of the wall and are returned a short distance into the east and west walls of the tower. One is at the level of the first floor of the tower, 33ft. long; the other is below the roof line and is stepped down under the arrow slit. As the wall had been thoroughly grouted by gravity from the other face in 1932, these measures were deemed sufficient to make the structure rigid.

West Gate, Winchester: The Northern Face before Treatment.

The disused chimneys were removed and the one still used for the fireplace on the first floor of the tower was reconstructed with a bend, in an effort to obviate down draught. Its brick top was removed and a low pot was inserted behind the triangular-sectioned coping, with which the wall top is finished. This wall top is not original, but is in keeping with the modern finish of the remainder of the thin parapet at roof level.

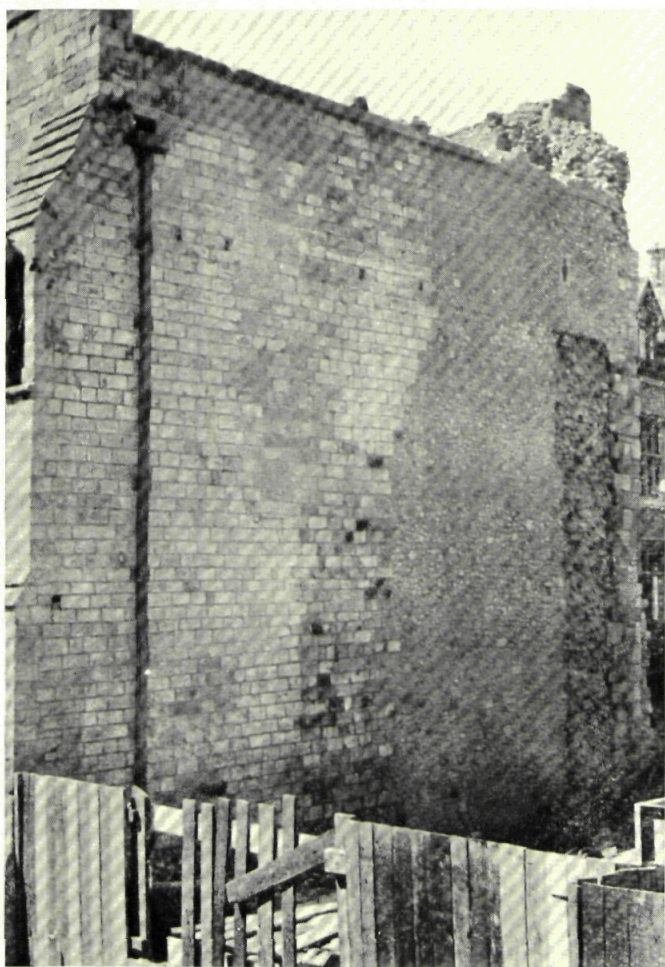
PLATE II.

West Gate, Winchester : The Northern Face after Treatment.

Although the ashlar refacing is certainly of comparatively recent date, it did not seem feasible to remove it in favour of a core finish or a completely modern imitation of the, probably original, flint and stone facing, such as can be seen on the western face of the tower. It has, therefore, been retained, being merely re-pointed where necessary, and new work of the same character has been carried across the two more modern doorways in it. When the lower large fireplace was removed, it was found that the original flint face, shortly to be described, came only up to its western side. The ashlar facing has, therefore, been rebuilt up to this vertical line. Above the position of this fireplace, however, the line of junction between ashlar and flint face has been retained as it was found, *i.e.* on an irregular, diagonal line.

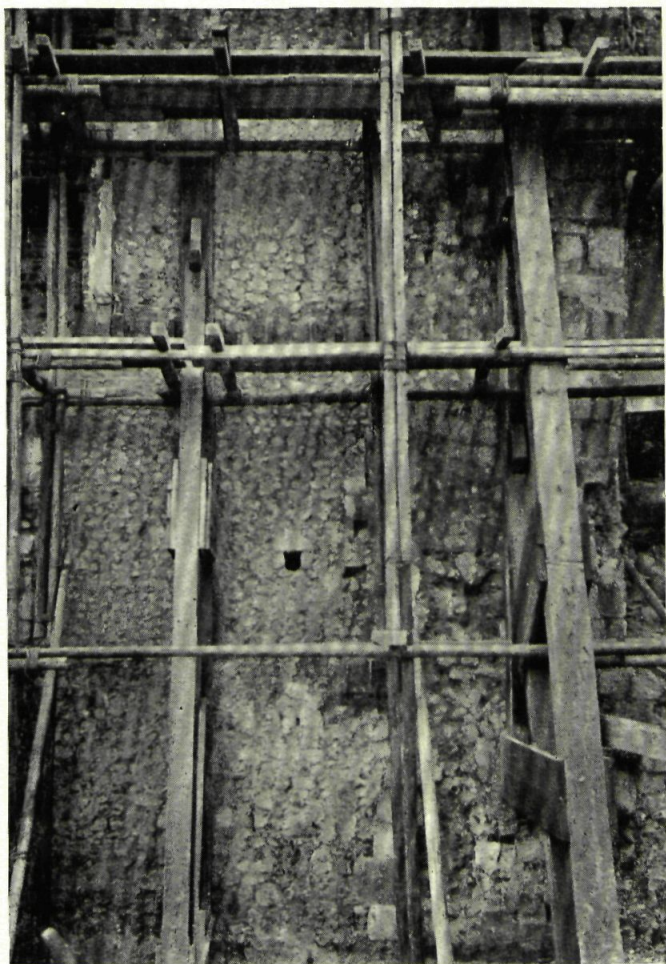
PLATE III.

The presumed site of the abutment of the Town Wall had a very rough flint face, which contrasted with the work to the east and was obviously a modern refacing (Fig. 3). This point confirms the location of the Town Wall in this position. Some 21 feet north of the tower a short piece of flint wall<sup>1</sup> faced only on the eastern side and running north to south for 11 feet was found to rest on the natural surface of the ground. The line of this face, if produced southward, would join the tower precisely at the most likely point for the abutment of the eastern face of the Town Wall. In view of these slight indications the face of the tower between the point last mentioned and the ashlar of the angle has been rendered in flint and stone core to suggest the abutment of the Town Wall (Fig. 4).

West Gate, Winchester: Site of the Abutment of the Town Wall,  
before Treatment.

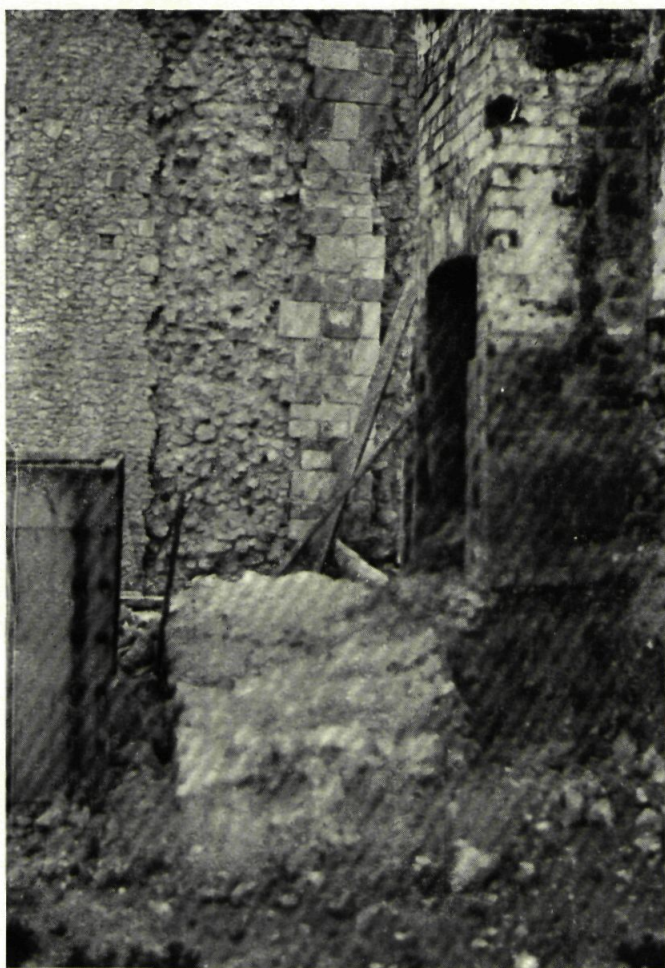
PLATE IV.

West Gate, Winchester: Site of the Abutment of the Town Wall,  
after Treatment.

No tuskers have been inserted, because it was felt that the angles of the abutment may have been turned in ashlar, but that to put new ashlar there would have been to make the evidence appear more definite than it really was. This core abutment has been carried up to below the probable level of the wall-walk, which seems to be indicated by the position of a narrow slit, presumably set to command it. There is certainly no indication that access could be obtained from the wall-walk to the tower.
