## THE PILGRIMS' HALL, WINCHESTER

By JOHN CROOK

The substantial medieval building known as the 'Pilgrims' Hall', Winchester, merits further study than it has received to date. This paper describes not only the well-known hammer-beam roof of the Hall itself but also the concealed timber-framing of a second, adjoining hall of the same 'build', complete with service bay: a more typical medieval hall, in fact, than the actual 'Pilgrims' Hall' which is probably mis-named. This second hall formed part of the same original building as the Pilgrims' Hall but was converted into a dwelling-house in the 17th century. Its remains are of particular significance in the study of aisled-hall derivatives, for they include a hitherto unknown base-cruck truss. Also described are the remains of an early form of wainscotting. A comparison of the two halls with other related examples, together with a study of the joints employed in the framing, and the decorative details, suggest a construction date at the beginning of the 14th century.

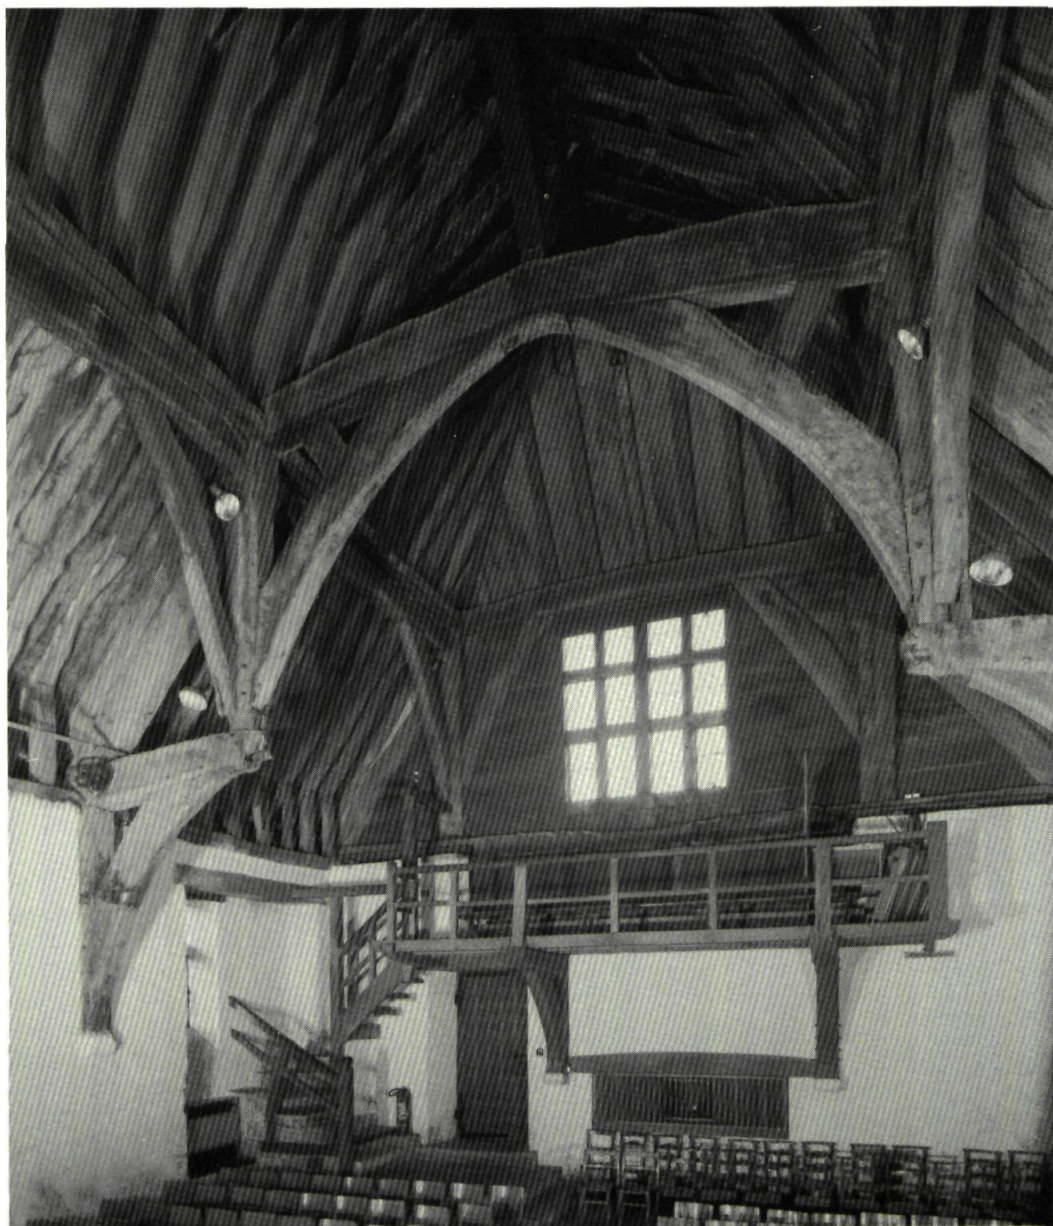
Fig. 1. Pilgrims' Hall, Winchester. Hammer-beam truss V and end truss VII viewed from the south. Photo A F Kersting.

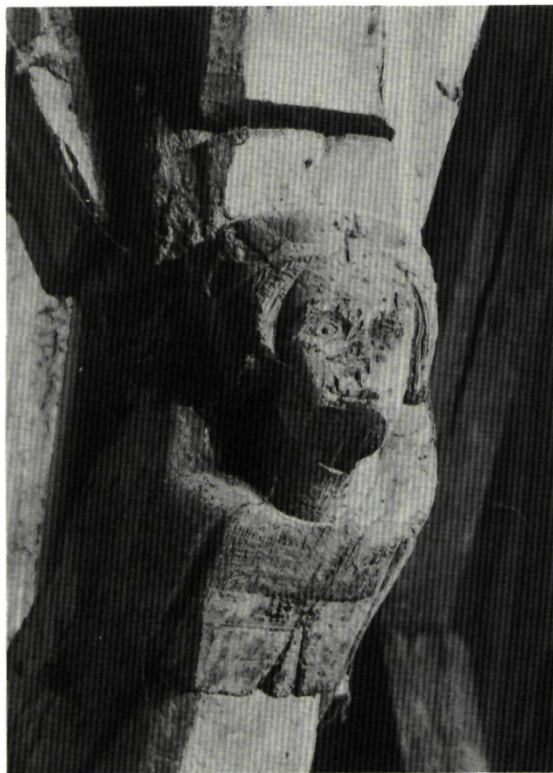
Fig. 9. Pilgrims' Hall, Winchester. Crowned head terminating west hammer beam of truss IV.

heads carved in the end-grain of the hammer beams is more controversial. As we have seen, Nisbett (1894, 77) stressed the resemblance between the *coiffure* of the head at the east end of truss V (Fig. 10) and that of the tomb-effigy of Edward II at Gloucester. He may, however, have chosen this example because it was well-known. It must be said that there is a considerable difference between the stiffly delin-

eated locks and tight end-roll of the hair of the Pilgrims' Hall head and the undulating, interweaving, *bouffant* style of the head of Edward II: a difference which is not perhaps merely explained by the exigencies of the different materials used. Indeed the *coiffure* of the Pilgrims' Hall head bears comparison with earlier examples—for as Lawrence Stone (1955, 161) emphasises, the first beginnings of what he calls

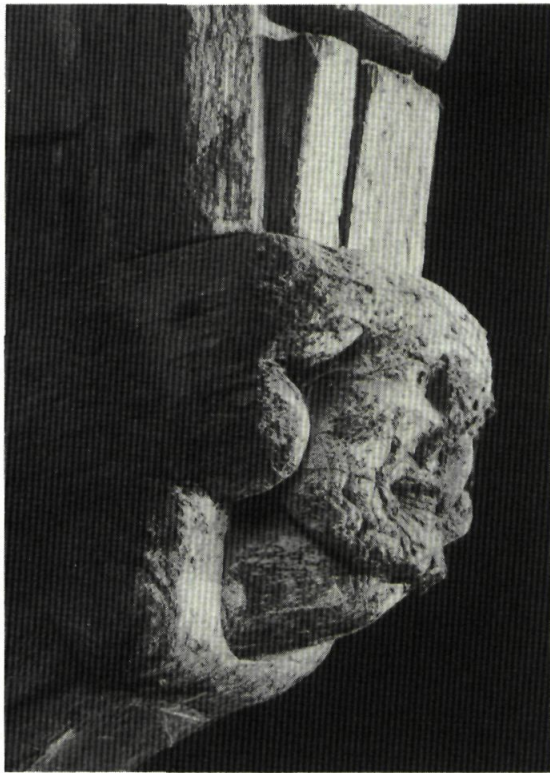
Fig. 10. Pilgrims' Hall, Winchester. Head terminating east hammer beam of truss V.
