## WATER POWER AT BROWNWICH FARM, TITCHFIELD

*By* EDWIN COURSE

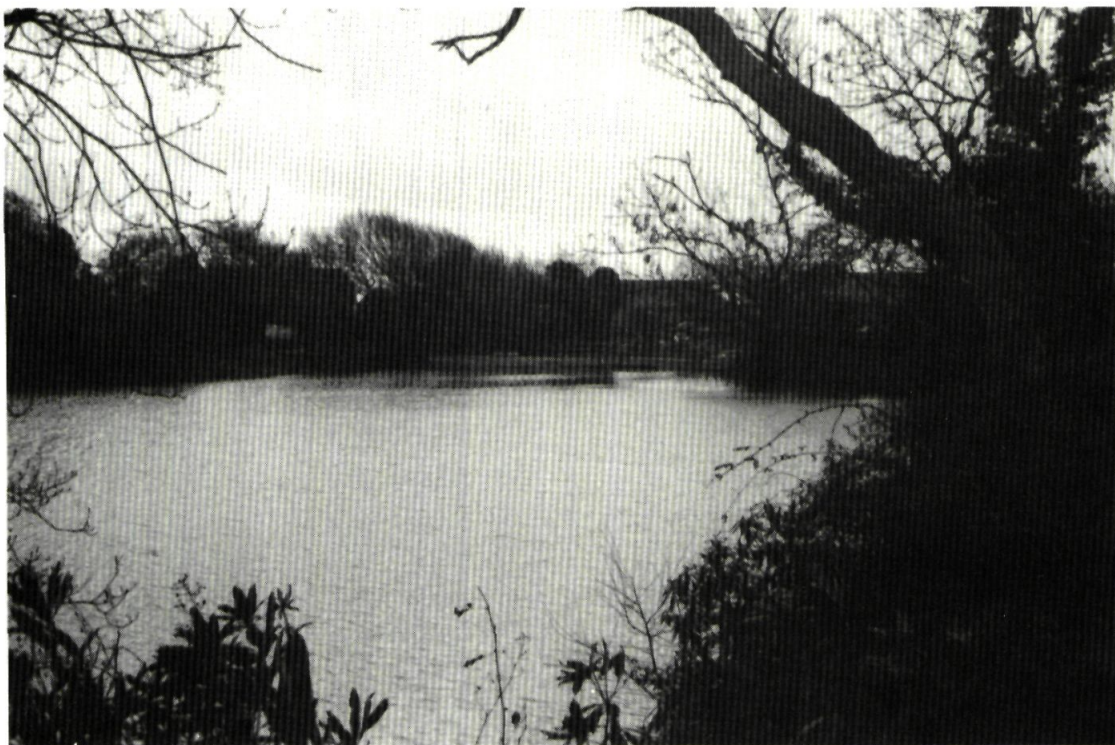
Fig 1. View of the pond which was the source of power for the Brownwich Farm installation. Photo: author.

The source of water was the large pond adjoining the farm, believed to have been a fishpond of Titchfield Abbey (Fig 1). The outline of the pond is shown on a number of maps, and these indicate the way in which the

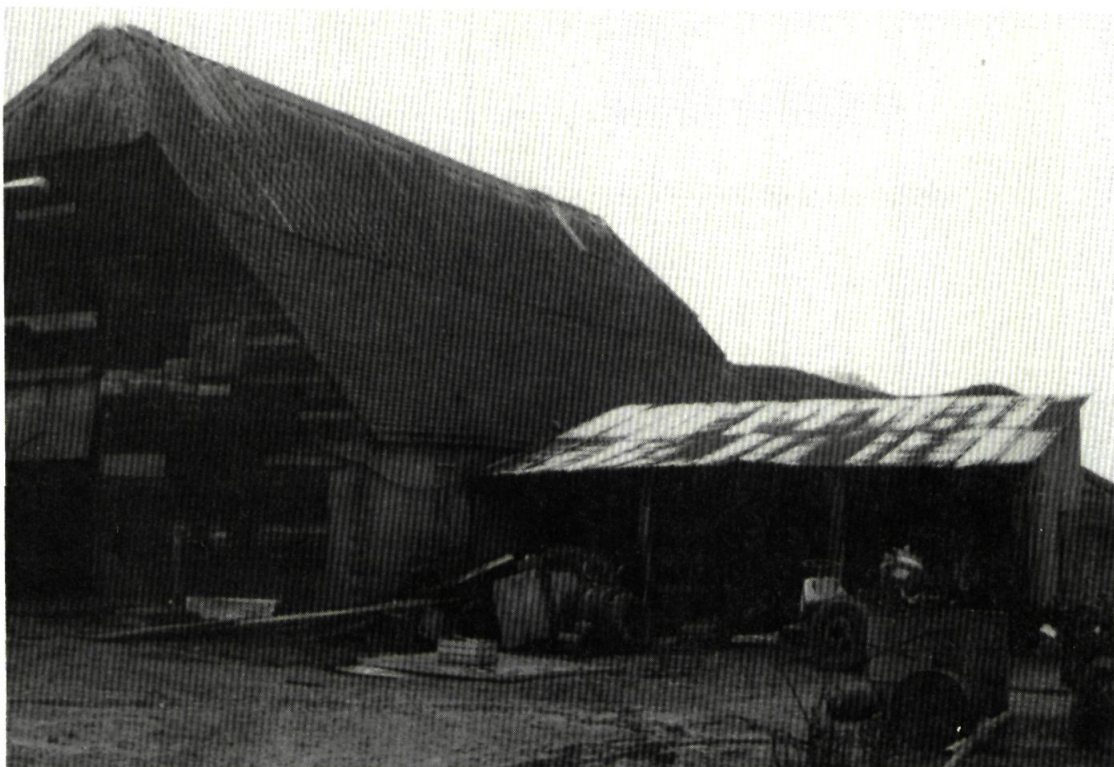
Fig 3. Brownwich Farm: view of the barn and the leanto over the wheelpit. Photo: author.
