## THREE HAMPSHIRE WEALDEN HOUSES

By ELIZABETH LEWIS

*Three medieval hall houses of Wealden type at Andover, Headley and Chalton are described. Documentary sources for Suters, Headley, suggest it was purpose built as a church house after 1520. The distribution, form and structural characteristics of Wealdens so far recognised in Hampshire are considered and compared with those in other counties.*

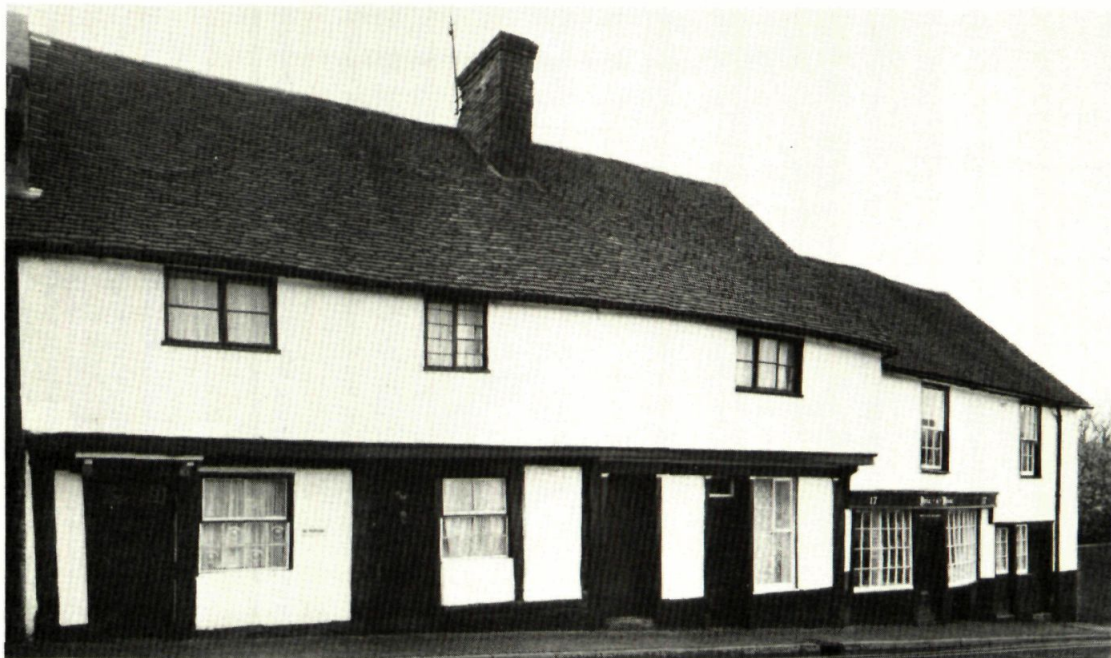
Fig 11. Exterior of 11-13 Chantry Street, Andover (RCHME).

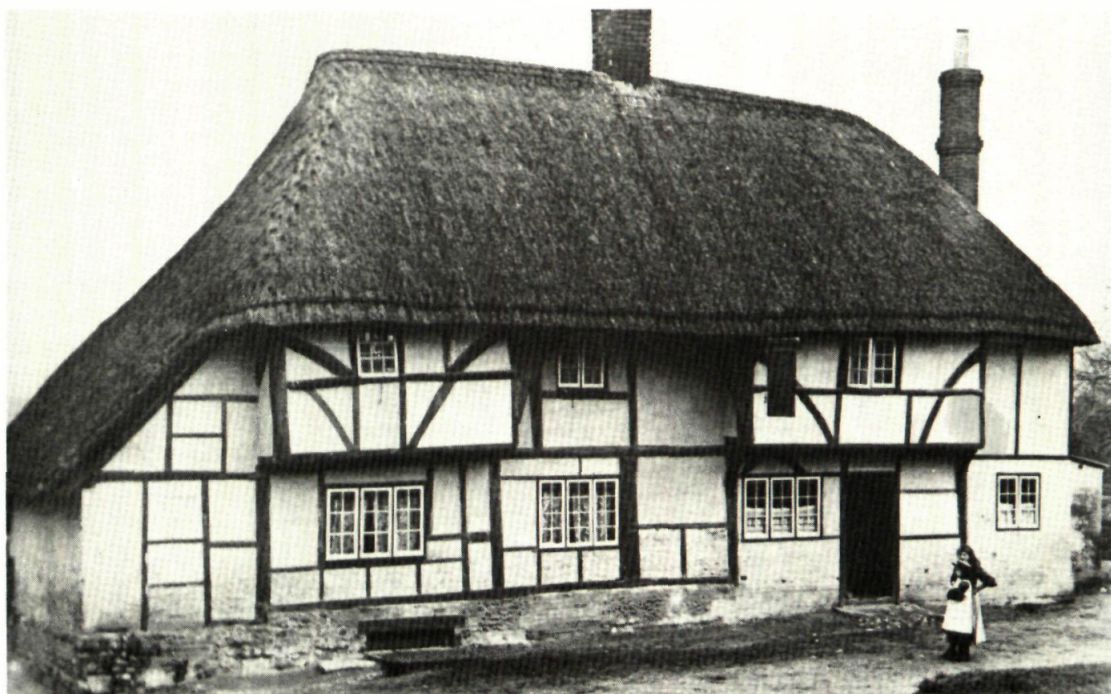
Fig 12. The Red Lion about 1880-1900.

moulded. It is interesting that subsequent alterations have hardly improved the status of the house at all, being confined to adding a smoke bay (followed by a brick chimney), a cellar, side and end service outshots and a two-storey extension at the service end, all strictly functional. It was probably an ale house for a considerable part of its history and its appearance has hardly altered since photographs were taken at the turn of the century (Fig 12).
