**ROMAN ROAD AT BEDHAMPTON.**

**NOTES ON THREE ANCIENT BUILDINGS  
IN AND NEAR HAMBLEDON, NOT NOTICED IN  
"THE VICTORIA COUNTY HISTORY."**

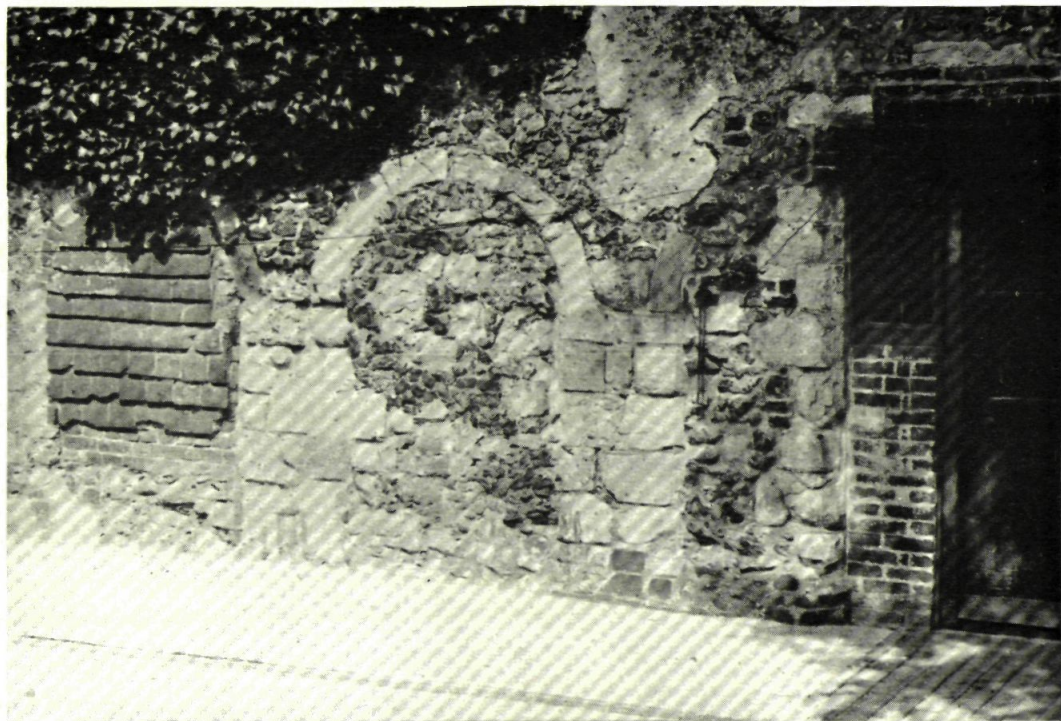
**THE MANOR FARM, HAMBLEDON.**

Part of South wall, showing two blocked round-headed arches, and remains of a third.

**T**HE MANOR FARM, HAMBLEDON. The south wing appears to date from c. 1200. It is a two-storeyed building, consisting of a western part about 36ft. by 18ft. and an eastern part 21ft. by 11ft., interior measurements. The north walls of the two parts are in line, with a buttress at the junction. There is another buttress in the middle of the west wall. The walls are 3ft. thick in the lower storey, set back to take the floor in the upper storey. They are of flint rubble with chalk dressings and quoins. There is a good deal of old plaster, especially on the east wall, and I believe the whole, including the chalk, was covered with plaster. With the loss of the plaster the chalk has weathered badly and there is a good deal of patching in brick of various dates, especially in the buttresses. The west front has recently been covered with Portland cement. The only original doorway remaining is an interior one, connecting the upper storeys in the eastern and western parts. It is round-headed and is near the north end of the cross wall. The only opening in the east wall appears to have been a narrow rectangular

light, high in the gable. This does not show inside. In the other walls are also narrow rectangular lights, with two wider ones, also apparently original. In the south wall of the eastern part is a blocked round-headed arch, its head about 4ft. above ground level. A recess in the interior wall appears to show that there were steps down to a cellar here. In the south wall of the western part was a range of three round-headed arches, two now blocked and the eastern one mainly destroyed when a doorway was inserted in the sixteenth century. The chalk blocks of its eastern jamb were used in this doorway. There is one blocked round-headed arch in the north wall of this part; the western part of this wall is masked by a wing added in the sixteenth century.
